# RUST-OLEUM INDUSTRIAL BRANDS SUCCESS STORY #042

**COMPANY:** Christopher Ranch

**PRODUCT:** Noxyde, Industrial Choice 5200 System DTM Acrylic

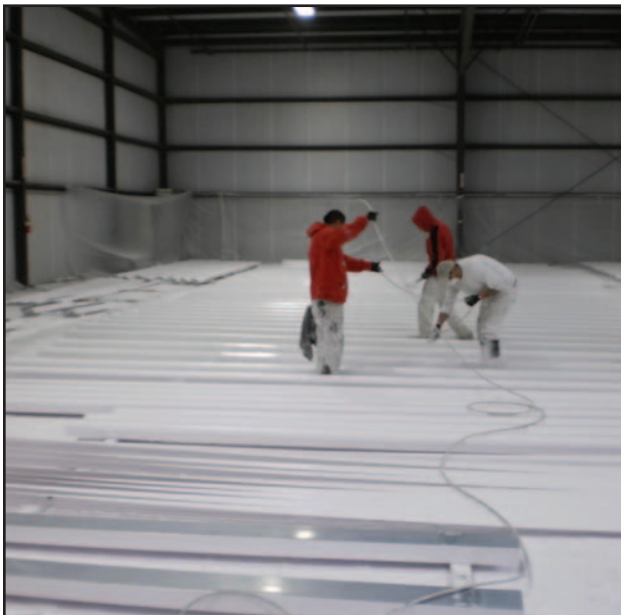
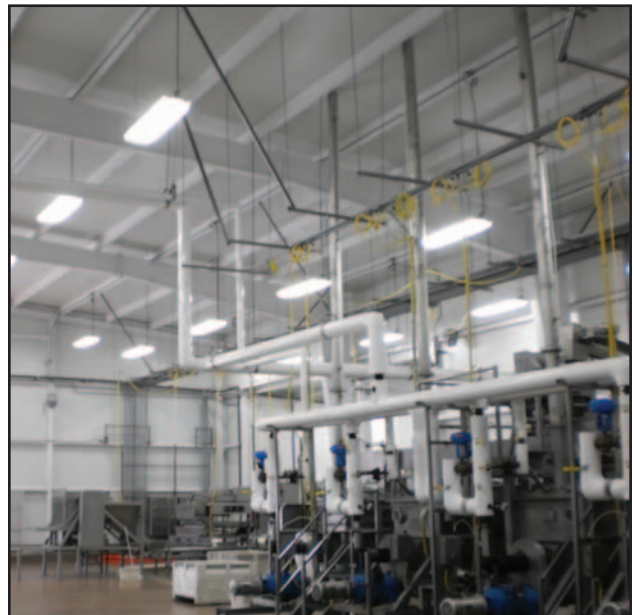
Christopher Ranch, a garlic farm in the Santa Clara Valley of California, noticed extreme rusting on the steel columns, beams and purlins of their interior processing facility. At the farm, previously applied epoxy coating systems were not holding up under regular washings. As a result, the facility experienced aggressive rusting. Account Manager, Steve Sexton, visited the ranch to inspect the processing facility and understand their needs completely.

To combat the aggressive rusting, Noxyde along with Industrial Choice 5200 System DTM Acrylic were selected as a trustworthy combination for the facility. Noxyde, a heavy duty, water based elastomeric acrylic, provides long term corrosion protection with an easy spray application. After two coats of Noxyde, the area was top coated with Industrial Choice 5200 System DTM Acrylic. The 5200 System is a low VOC, low odor coating. After almost one year, the facility has not had any problems with rusting and the coating system is adhering well and is easy to maintain.
